## Extreme Dry Conditions During Installation

### WOOD MOISTURE CONTENT BY AREA

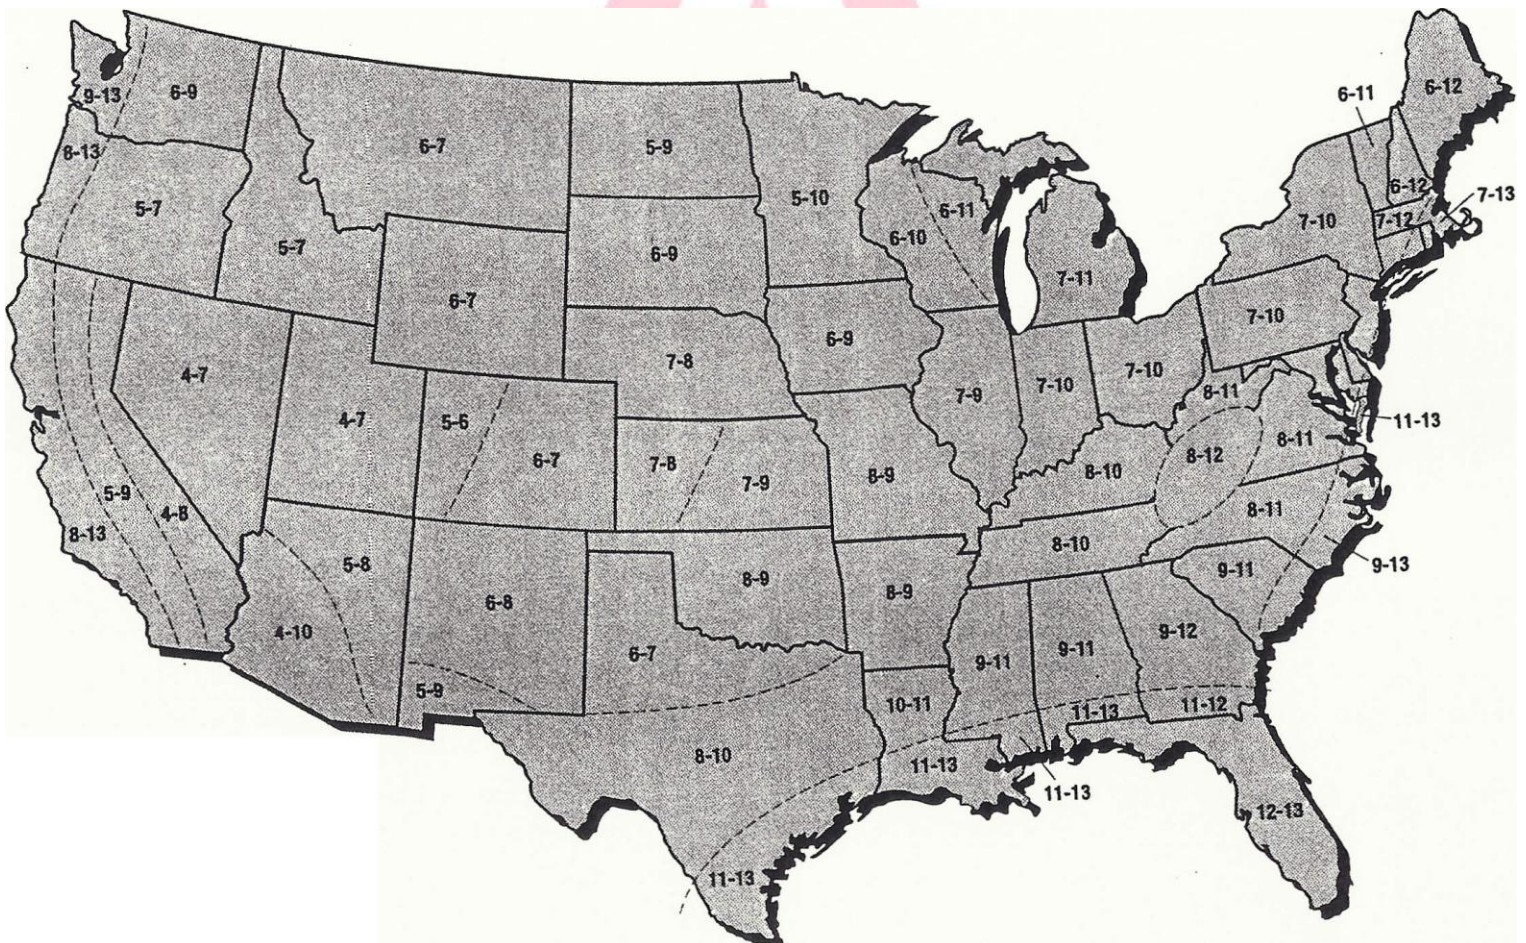
Variation of average moisture content for wood used indoors:

For each set of figures: The first number represents the average moisture content measured during January, and the second figure is, the average moisture content during July.

The region of the country, available mechanicals, and expected operation of the mechanical units, determines the expected wood moisture content range for the occupied facility. The attached USDA map provides a general range of wood moisture for each region of the country.
