## Bleacher Attachment

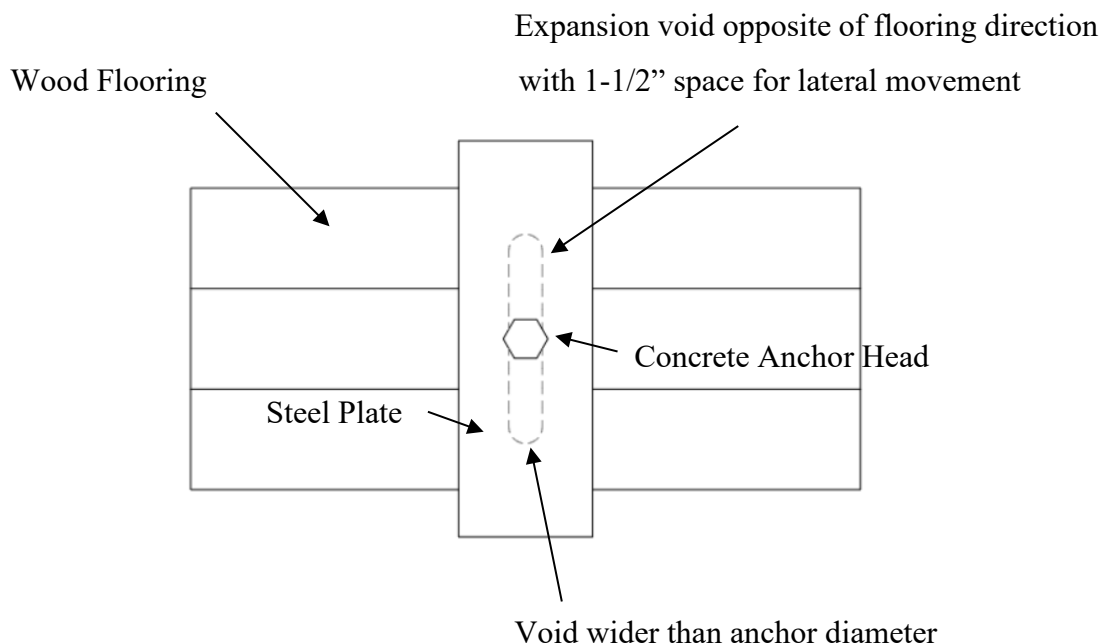
As described by the Maple Flooring Manufacturers Association, 1-1/2" expansion voids should be included between system components and all obstructions including walls and vertical penetrations. If bleacher anchorage of base supports is required, this must be provided by penetrating through the flooring and subfloor system into the concrete slab. The detail below illustrates the manner in which expansion must be provided if concrete slab anchorage is required.

Fixed bleacher units should never be attached directly to hardwood athletic floors and are most preferably only attached to adjacent walls. Restriction of lateral movement commonly associated with seasonal changes in wood moisture content can create issues such as compression of wood flooring board edges as well as buckling surface areas of the floor.
