Bleacher Attachment

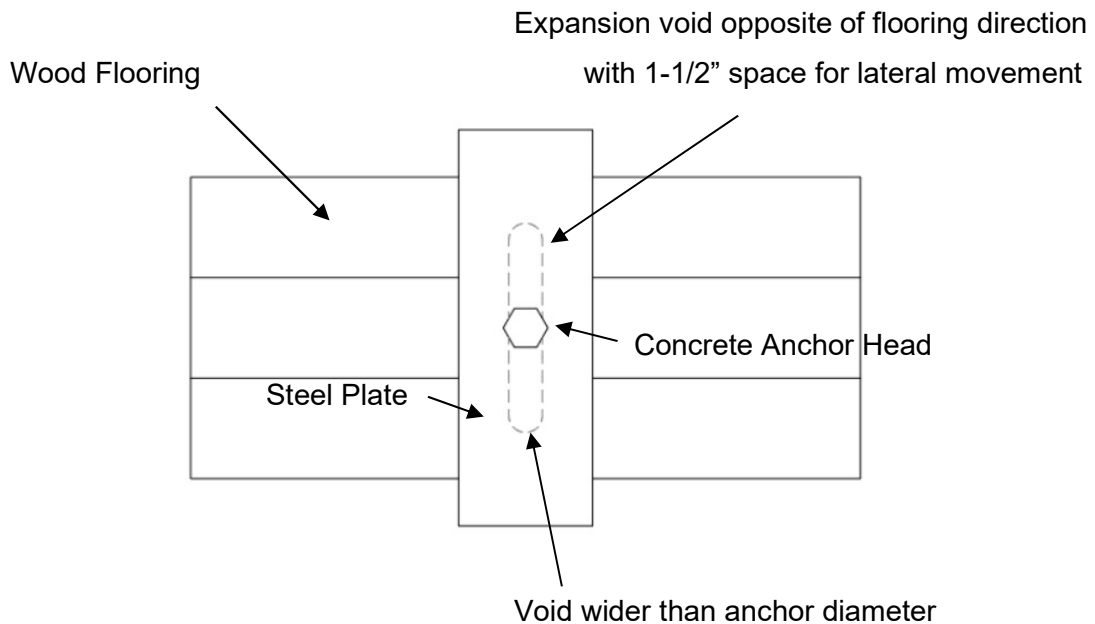
As described by the Maple Flooring Manufacturers Association, 1-1/2" expansion voids should be included between system components and all obstructions including walls and vertical penetrations. If bleacher anchorage of base supports is required, this must be provided by penetrating through the flooring and subfloor system into the concrete slab. The detail below illustrates the manner in which expansion must be provided if concrete slab anchorage is required.

Fixed bleacher units should never be attached directly to hardwood athletic floors and are most preferably only attached to adjacent walls. Restriction of lateral movement commonly associated with seasonal changes in wood moisture content can create issues such as compression of wood flooring board edges as well as buckling surface areas of the floor.
