# Bleacher Attachment

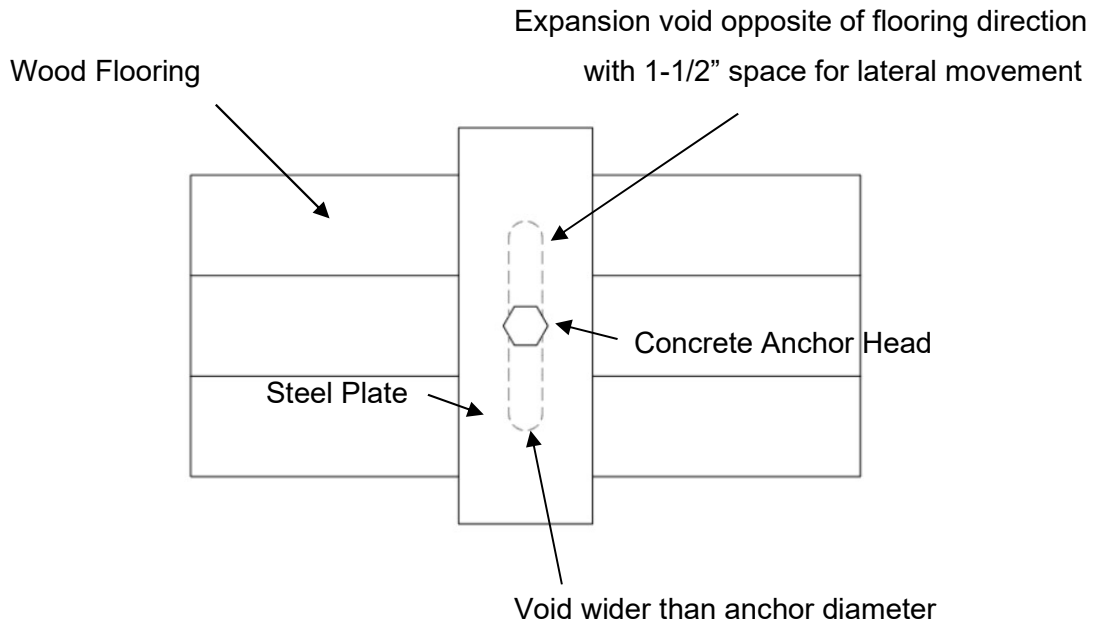
As described by the Maple Flooring Manufacturers Association, 1-1/2" expansion voids should be included between system components and all obstructions including walls and vertical penetrations. If bleacher anchorage of base supports is required, this must be provided by penetrating through the flooring and subfloor system into the concrete slab. The detail below illustrates the manner in which expansion must be provided if concrete slab anchorage is required.

Fixed bleacher units should never be attached directly to hardwood athletic floors and are most preferably only attached to adjacent walls. Restriction of lateral movement commonly associated with seasonal changes in wood moisture content can create issues such as compression of wood flooring board edges as well as buckling surface areas of the floor.
